# Microstructural investigations of Ni and Ni<sub>2</sub>Al<sub>3</sub> coatings exposed in biomass power plants

The present work investigates the corrosion resistance of Ni and Ni<sub>2</sub>Al<sub>3</sub> coated austenitic stainless steel (TP347H) tubes, which were exposed in a biomass-fired boiler with an outlet steam temperature of 540°C for 6757 h. The Ni<sub>2</sub>Al<sub>3</sub> coating was produced by electroplating Ni followed by low temperature pack cementation. After exposure, microstructural investigations were performed by light optical and electron microscopy (SEM-EDS). Electroplated Ni coatings were not protective in straw firing power plants and exhibited similar corrosion morphology as uncoated tubes. For Ni<sub>2</sub>Al<sub>3</sub> coatings, the nickel aluminide layer was no longer adherent to the tube and was only found within the deposit. However, Ni<sub>2</sub>Al<sub>3</sub> coatings had provided some protection compared to uncoated and Ni coated tubes. The formation of nickel chloride binds aggressive chlorine and slows down the active oxidation mechanism. In local areas, sulphidation corrosion attack of Ni was detected.

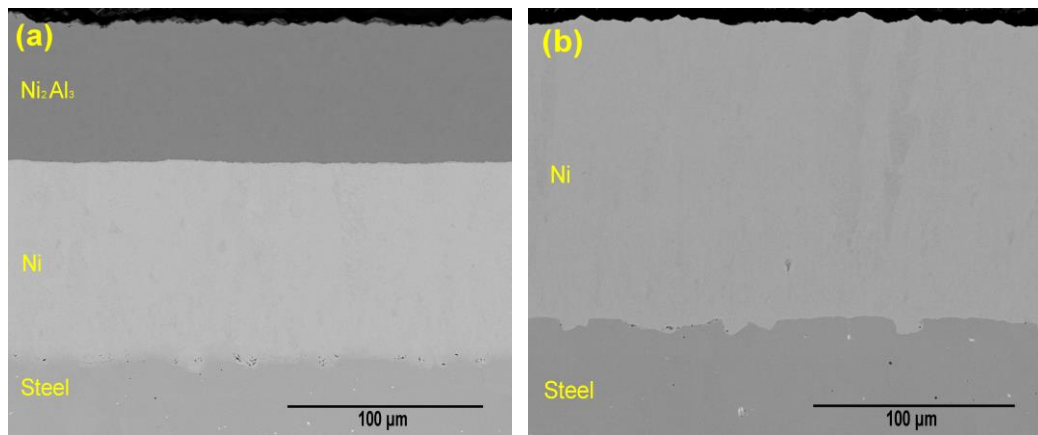
The Ni and Ni<sub>2</sub>Al<sub>3</sub> coatings were uniform with smooth interfaces and surfaces (Figure 3). The Ni-Al coating consisted of an outer Ni<sub>2</sub>Al<sub>3</sub> layer (thickness variation between 50 and 70  $\mu\text{m}$ ) and an inner Ni layer (100  $\mu\text{m}$ ) and was adherent to the steel. The Ni<sub>2</sub>Al<sub>3</sub> layer was identified by XRD (not shown). A very thin (<5  $\mu\text{m}$ ) layer of intermediate phases could be seen at the interface between Ni and Ni<sub>2</sub>Al<sub>3</sub>. Porosities could be observed at the Ni/steel interface. The Ni coating consisted of a single Ni layer with a thickness of about 125  $\mu\text{m}$ .

Figure 3. BSE-SEM micrograph of cross-section of (a) Ni<sub>2</sub>Al<sub>3</sub> coated and (b) Ni coated tube sections
